Technical News Bulletin

Elmira, New York, Feb. 19, 2009

Kit Significantly Improves Veritas™ iM Rotate Mechanism

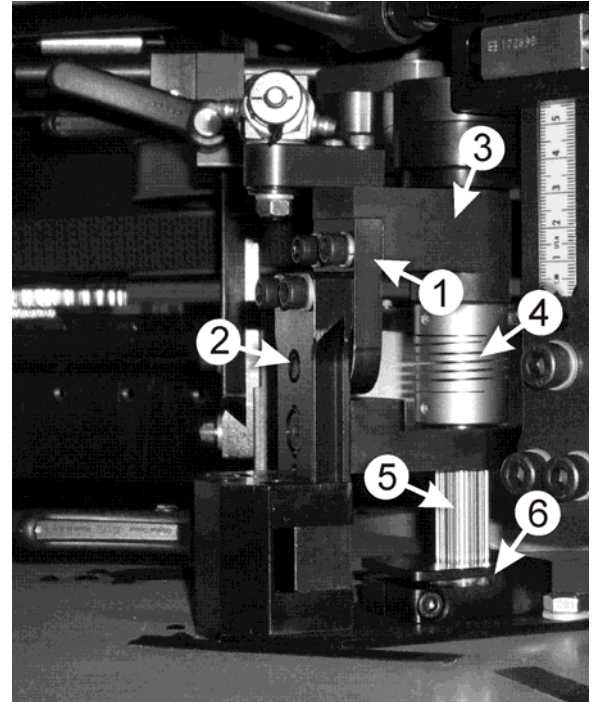
Figure 1: Modifications to upper parts of the rotator

The failure of the helical beam coupling was caused by the pivot of the rotator head at a location that caused the coupling to be axially misaligned when the rotator head was adjusted to hold down the bottle during rotation. This area of the rotator mechanism was improved by modifying the design of the coupling to place the pivot axis of the rotator head at a point that changed the axial misalignment to angular misalignment (refer to Figure 1). The angular misalignment is now between 1 and 2°, which is well within the 5° rating of the coupling.

The failure of the spline shaft and bushing from abrasion was caused by fretting corrosion of the spline shaft and the spline coupling. Fretting corrosion is caused by the combination of corrosion and the abrasive effects of corrosion product debris often seen in equipment with moving or vibrating parts. On the Veritas iM rotator this failure is caused by chafing of similar materials (the spline shaft and spline bushing) while sliding or vibrating under load. Two steps were taken to prevent and eliminate the failure of these parts.

1. New pivot plate
2. Pivot pin
3. Modified rotator body
4. Helical coupling
5. Spline shaft
6. Spline disk shield and disk shield housing

1. A dry film lubricant is applied to the spline bushing.
2. The side load and vibration of the spline shaft was decreased by moving the spline bushing to the bottom of the shaft. An additional benefit was better alignment and support of the spline shaft.

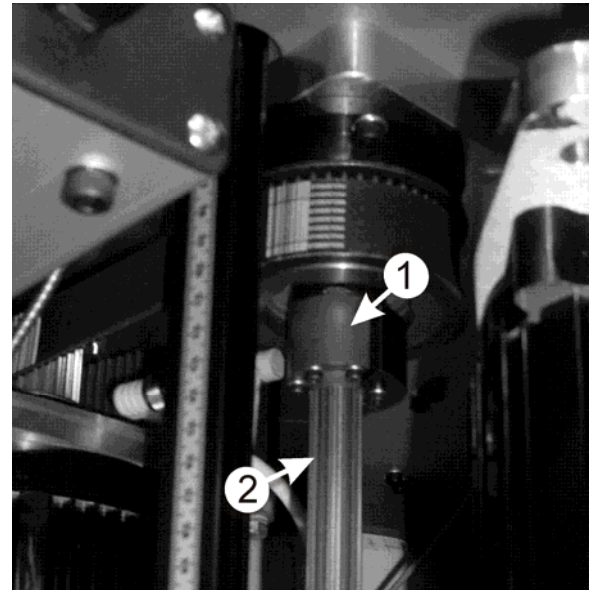
Figure 2: Modifications to lower part of rotator

Failures of the rotate head were caused by the spline shaft hitting the inside of the rotate head drive shaft when the rotator was turning. By relocating the spline bushing to the bottom of the spline shaft, spline shaft interference was eliminated (refer to Figure 2). This also decreases the maximum possible misalignment of the rotate head and spline shaft to ranges that are well within the tolerances for these parts. In addition to relocating the spline bushing, a Nylatron® disk shield has been added to a new housing located above the top plate to reduce the amount of debris that can enter the bushing.

1. Spline bushing relocated to bottom portion of the spline shaft
2. Spline shaft
